BLUE RIDGE PENSTOCK REHABILITATION

The Project

- TVA (Tennessee Valley Authority) is the owner and operator of the Blue Ridge Dam which is nearly 90 years old
- A 168" riveted steel penstock under this dam leads to a 25 MW hydroelectric power plant at dam base
- Shortly after construction a section of the penstock began to deform from external loading and required structural reinforcement.
- Original remedy was to install a steel reinforced, concrete filled girder through the center of the penstock 160' long by 18" thick and weighing 300 tons
- TVA/Paul Rizzo Assoc. Engineers remedy was to remove the girder and install a 147" x 1" thick steel liner within the penstock then grout the annular void
- **National Welding Corp.** was hired by **Garney Companies** to remove the girder, develop the installation means and install the new penstock
- **Northwest Pipe** laid out and provided the new penstock and reducers

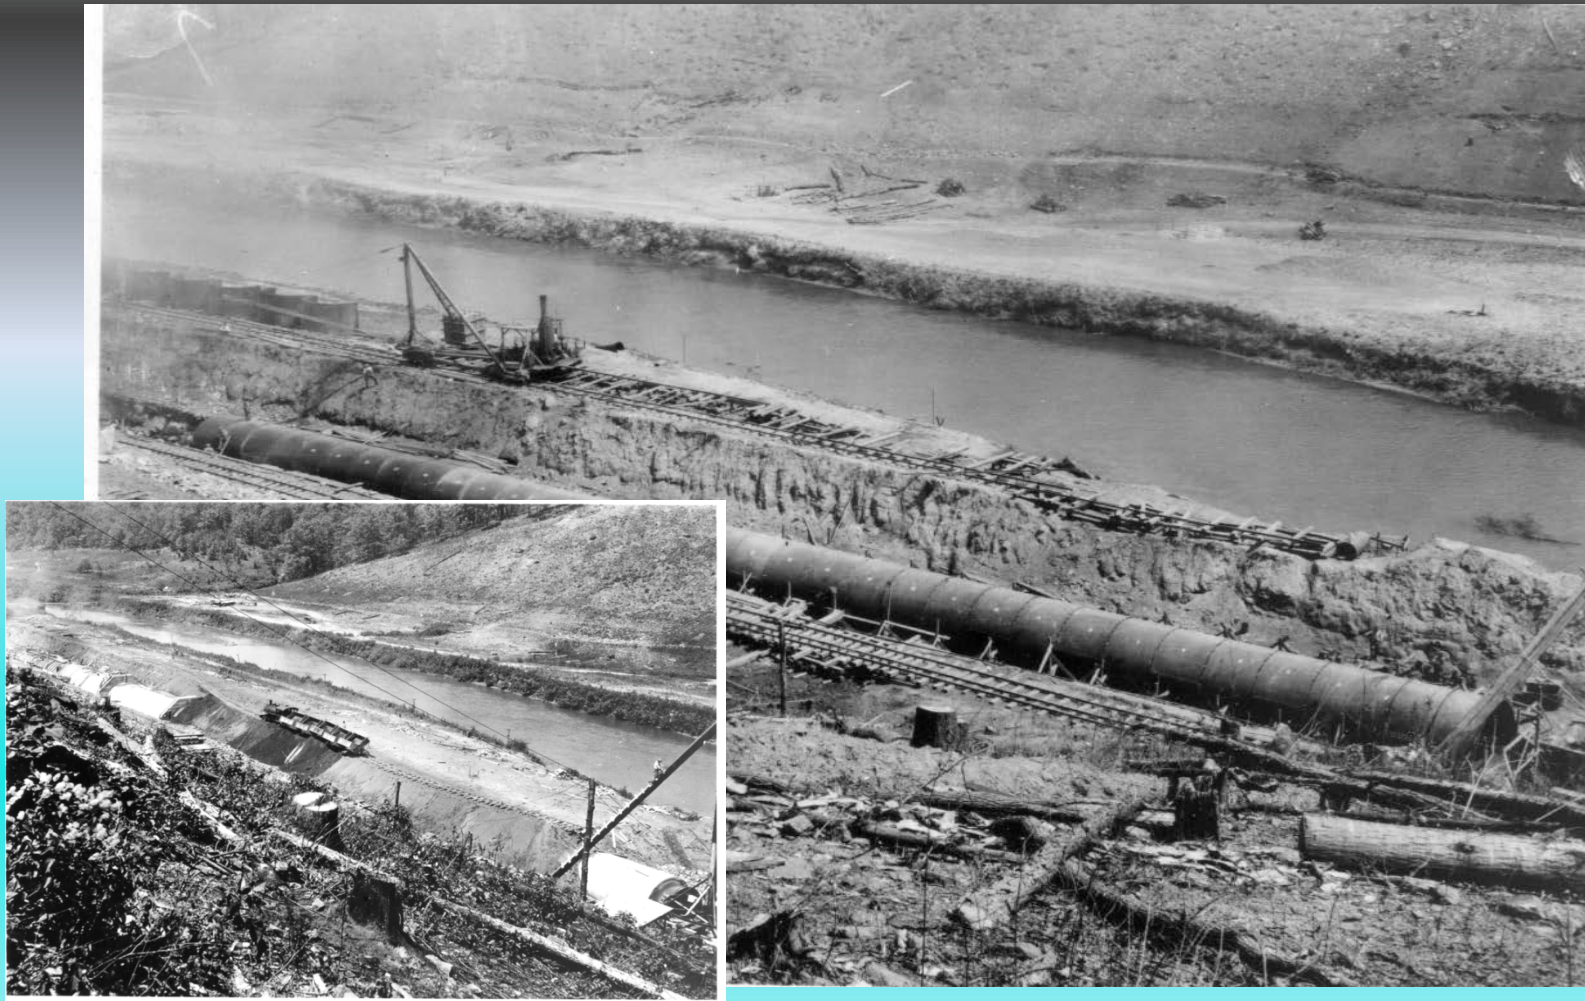
Original Penstock Construction

- Penstock 1050 ft long x 14 ft diameter riveted steel , encased in 4 ft reinforced concrete
- Penstock/Dam constructed between 1923 - 1931

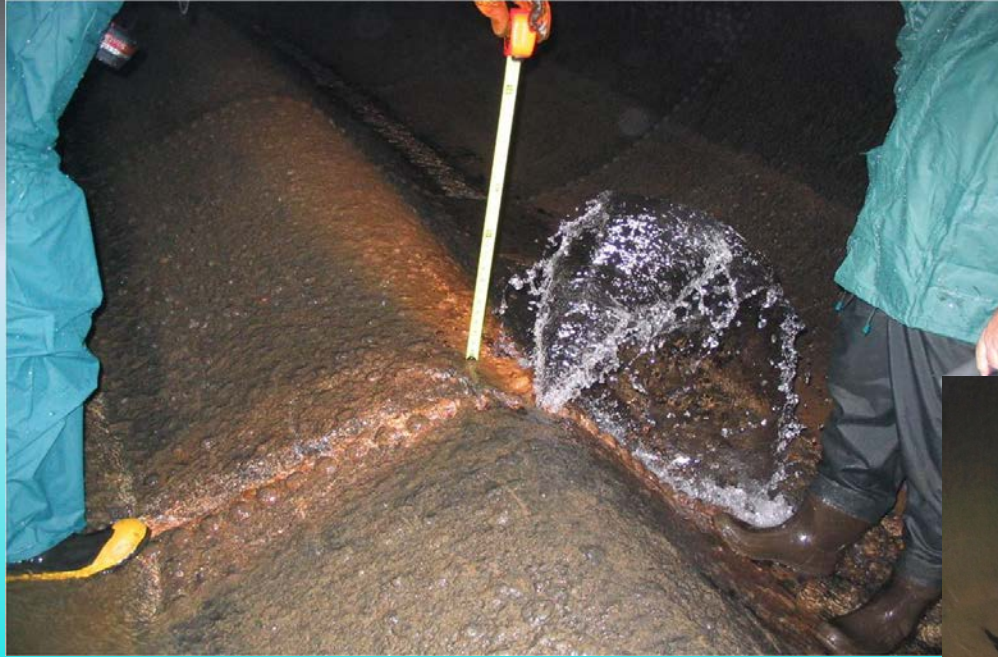
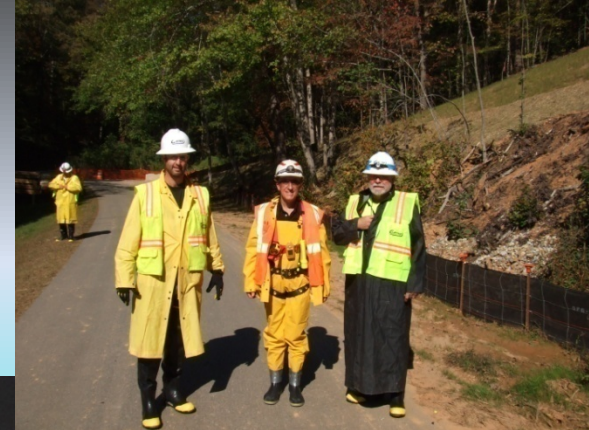
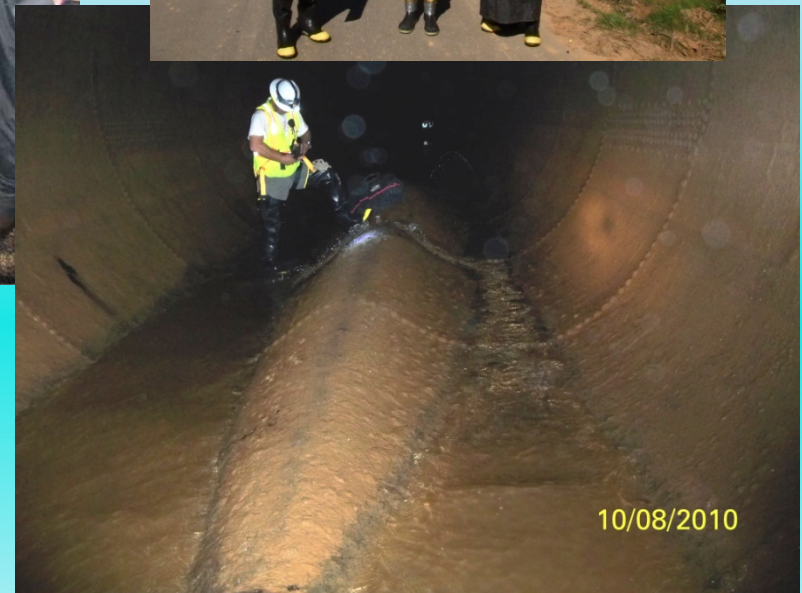
Penstock Buckling 60' Long x 36" Tall

PENSTOCK BUCKLING OCCURRED DUE TO EXTERNAL LOADING. BULGE WAS A WATER FILLED CAVITY

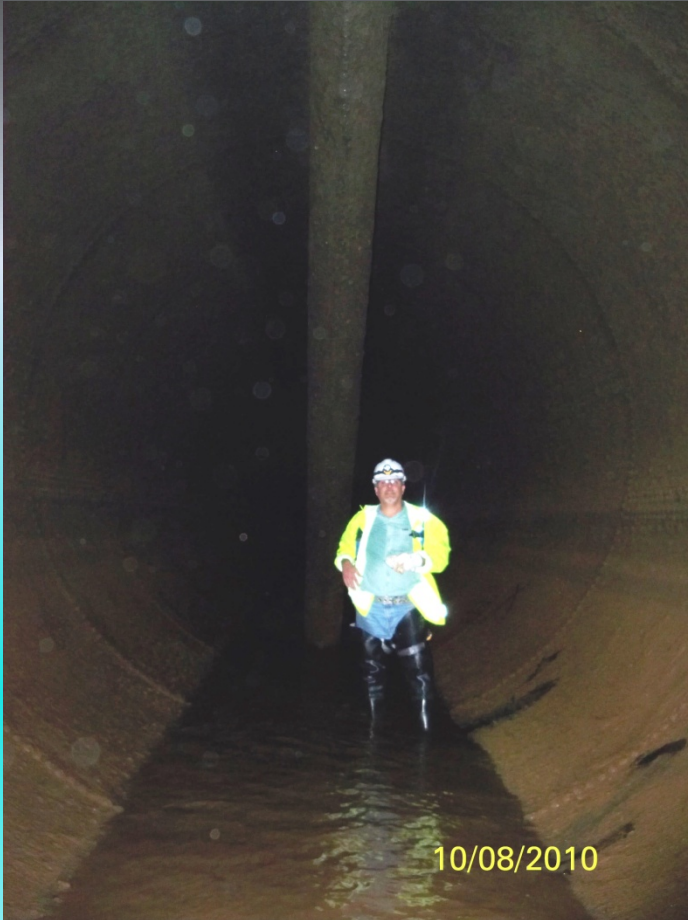
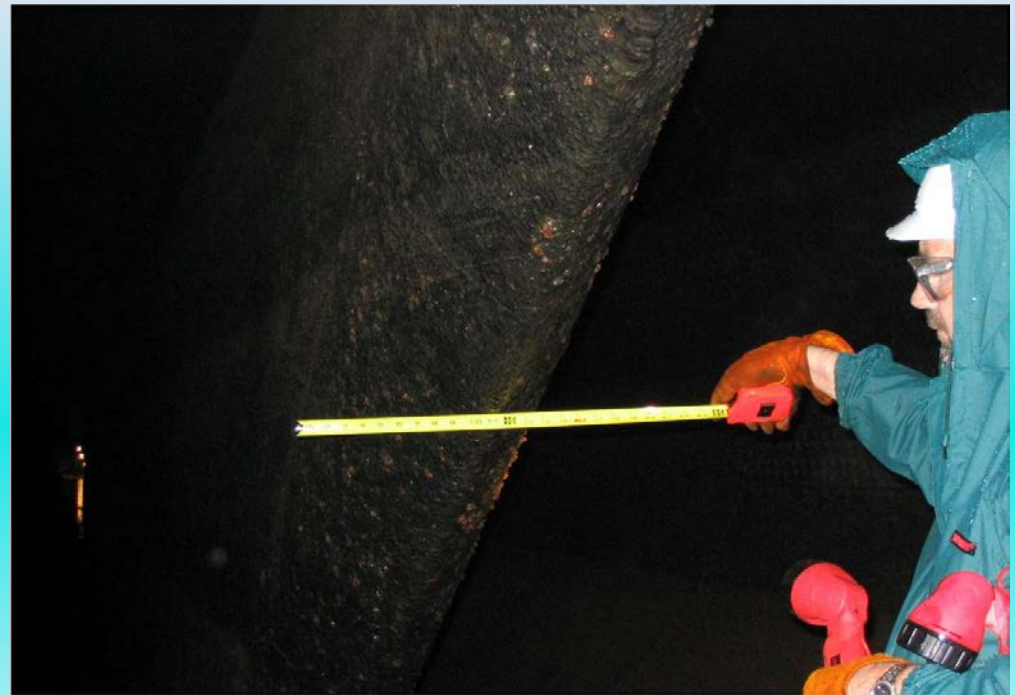
300 Ton Steel/Concrete Girder

GIRDER MEASURED 160 FEET LONG X 18" THICK AND 14' TALL (FLOOR TO CEILING). CONTAINED STEEL AND CONCRETE MIX WITH LIMITED ACCESS.

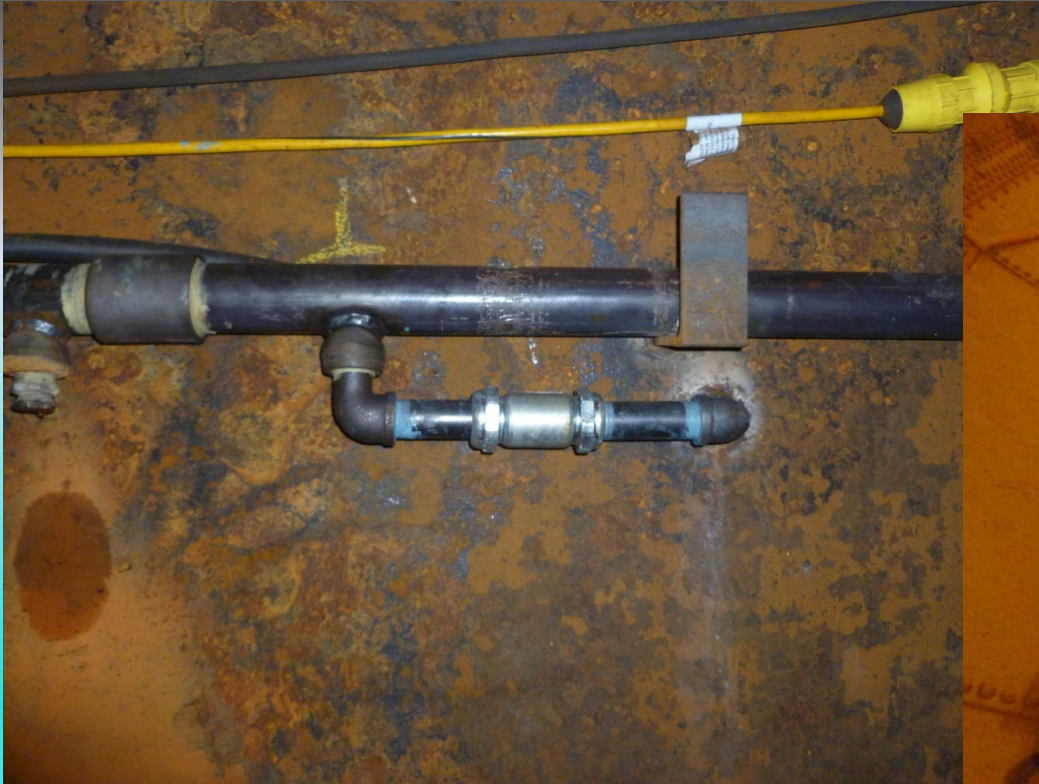
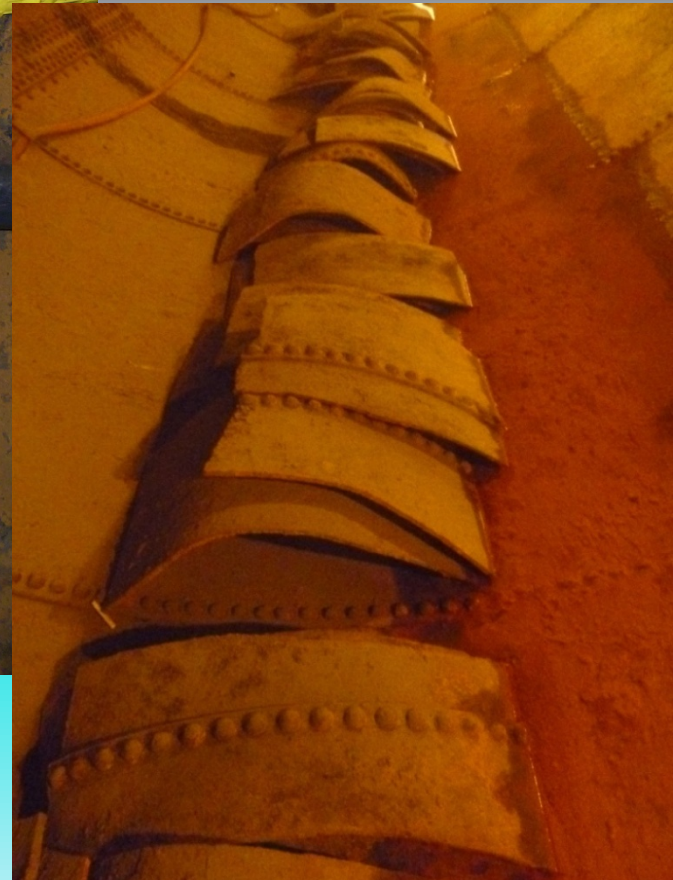
Reduce Pressure & Remove Bulge

**PENSTOCK STABILIZED BY REDUCING
EXTERNAL PRESSURE WHICH ALLOWED
REMOVAL OF BULGE**

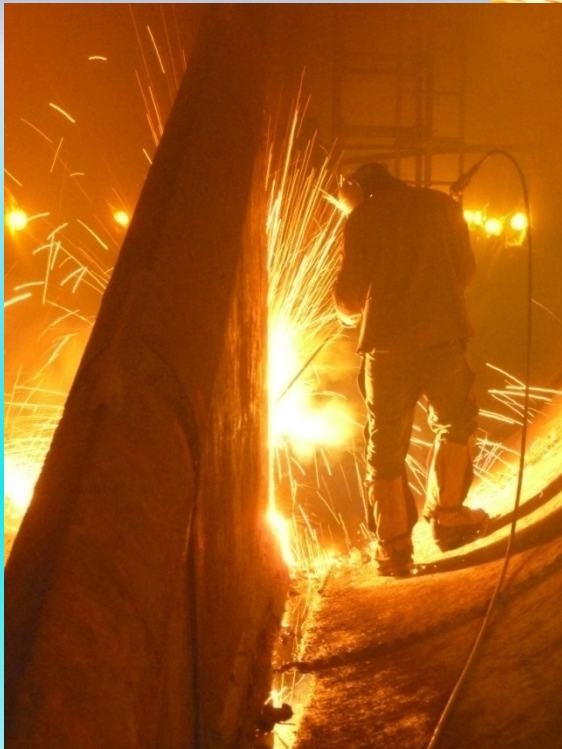
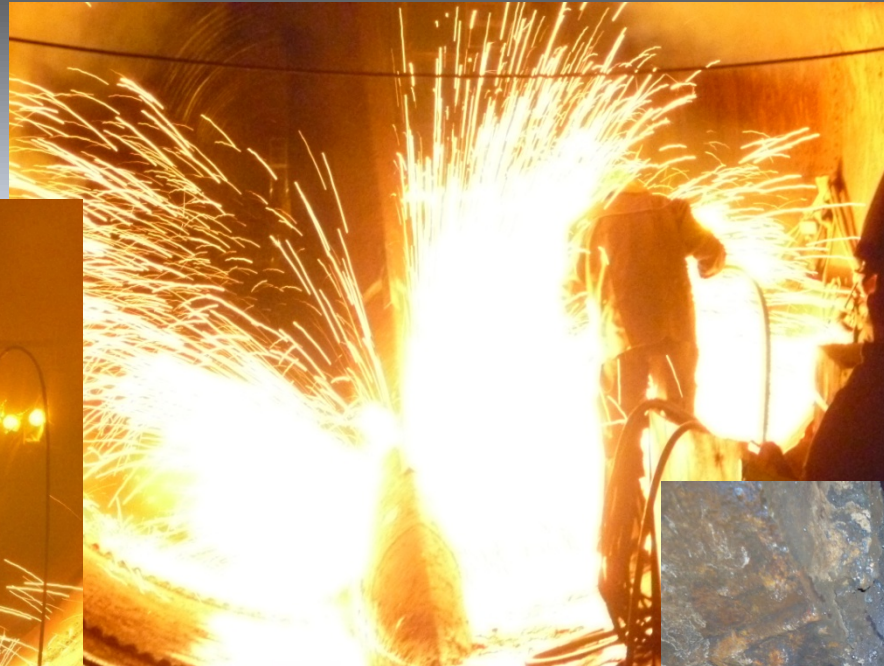
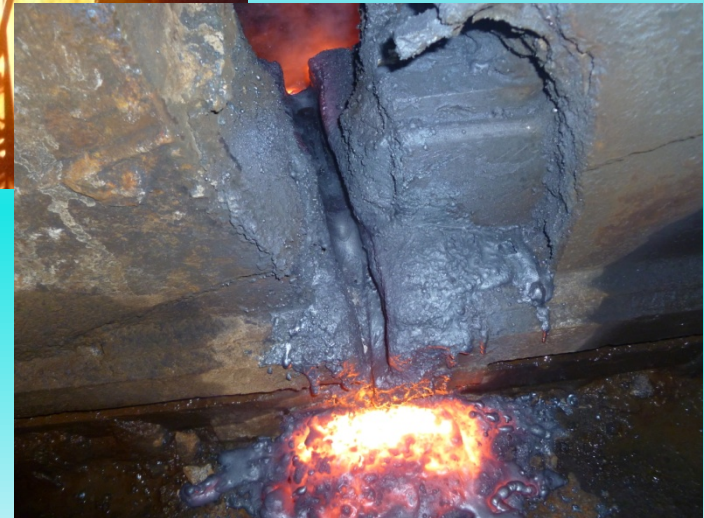
Removed 300 Ton Girder

**THERMIC (OXYGEN)
LANCE CUTTING TO
REMOVE STEEL AND
CONCRETE GIRDER**

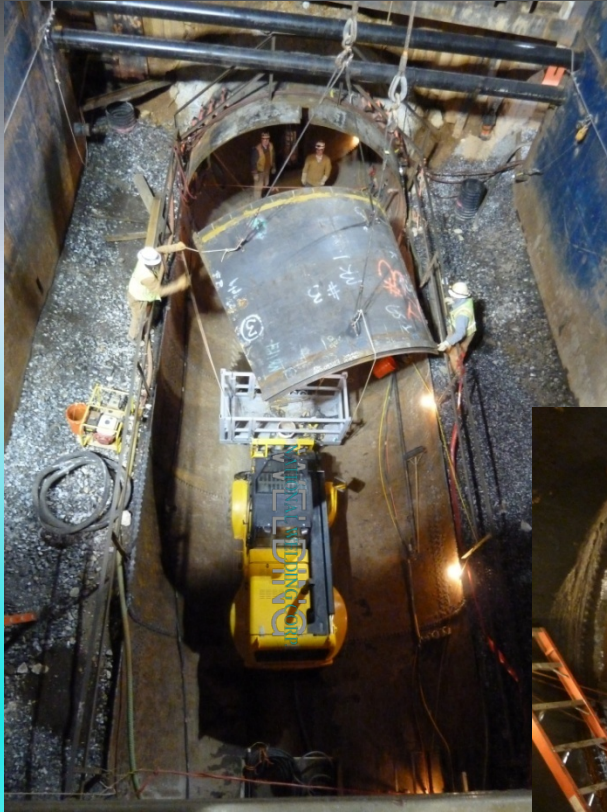
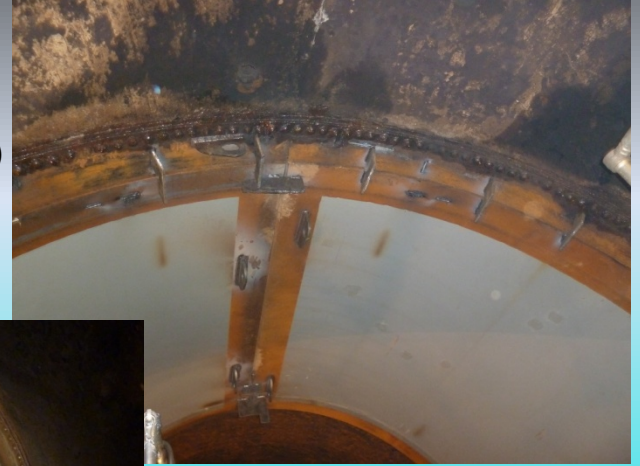
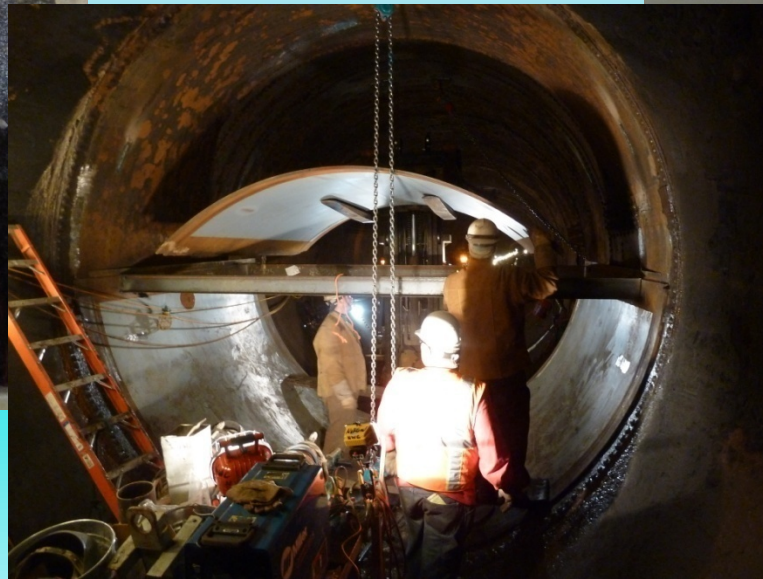
Reducer Assembly

168" TO 147" REDUCER
INSTALLED IN QUARTER
SECTIONS WEIGHING 4000
LBS EACH

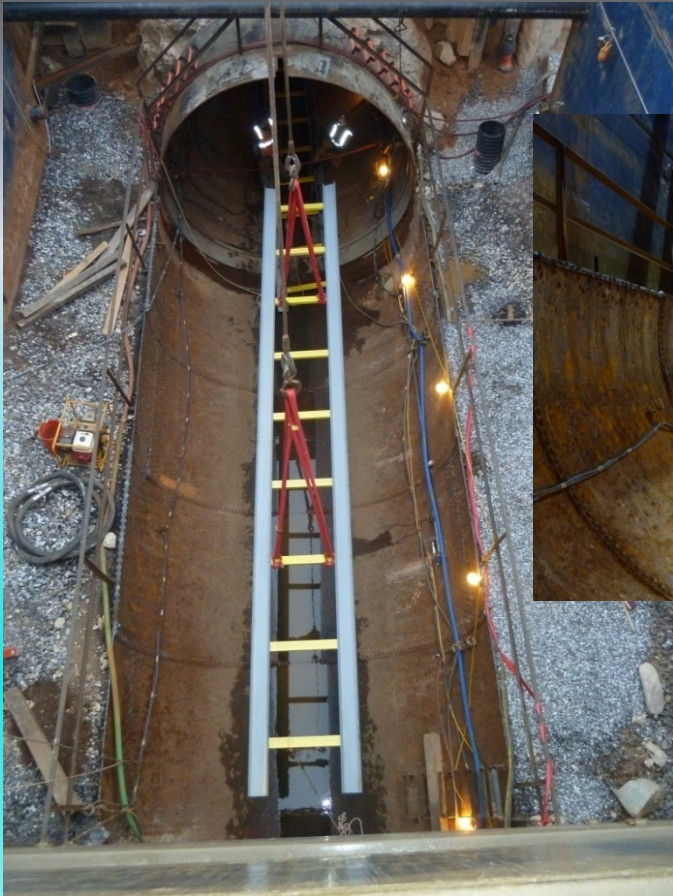
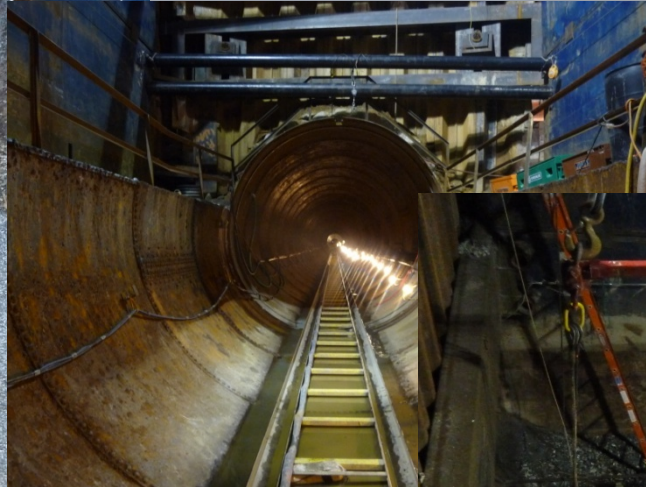
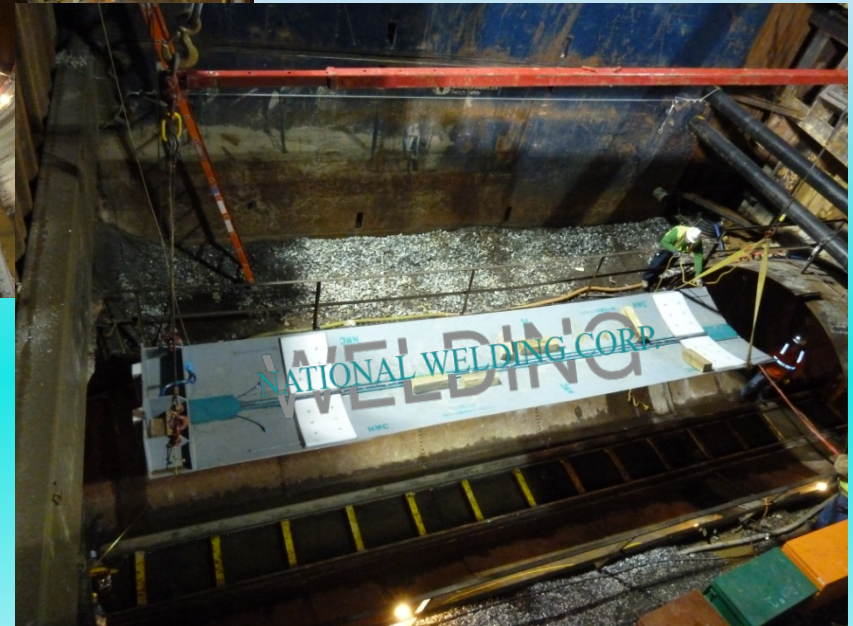
Install Rail Sections & Carrier

RADIAL MOUNTED
RAIL UNIQUE CARRIER

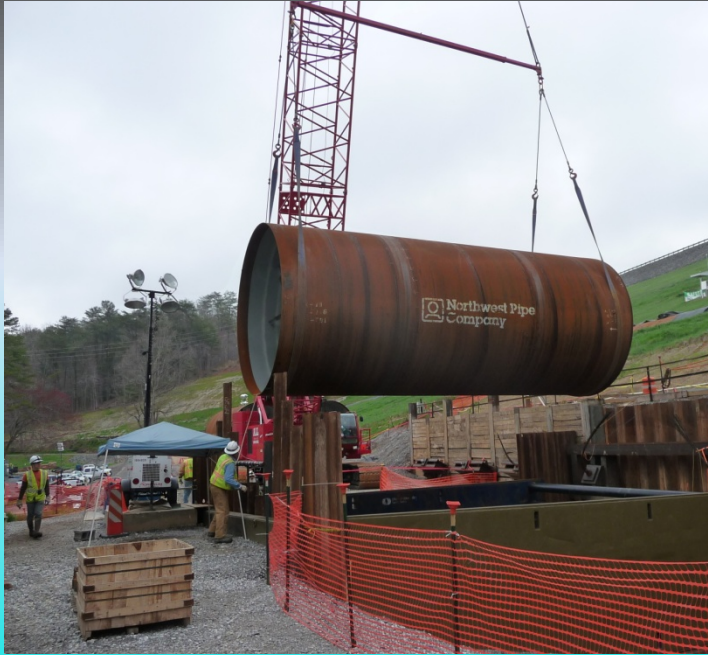
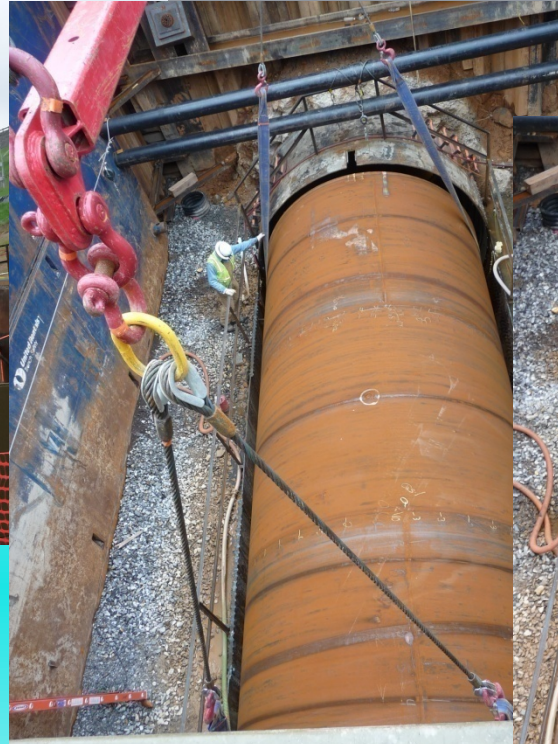
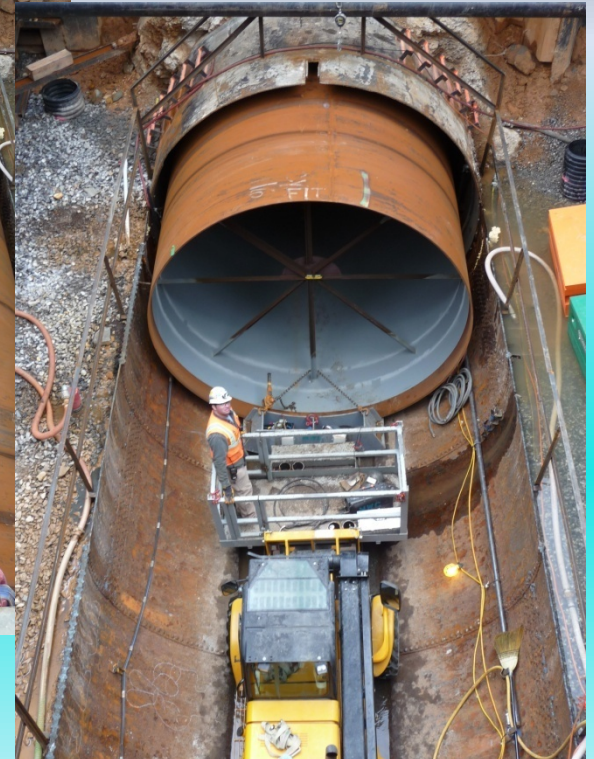
Penstock Installation

8" ANNULAR SPACE WITH
50,000 LB PIPE REQUIRED VERY
ACCURATE TOLERANCES &
GOOD CONTROLS

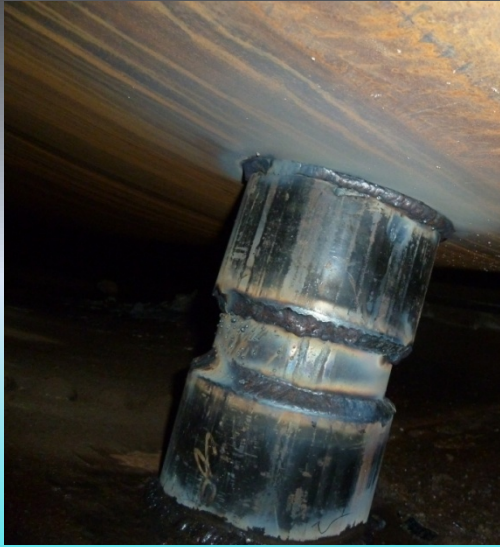
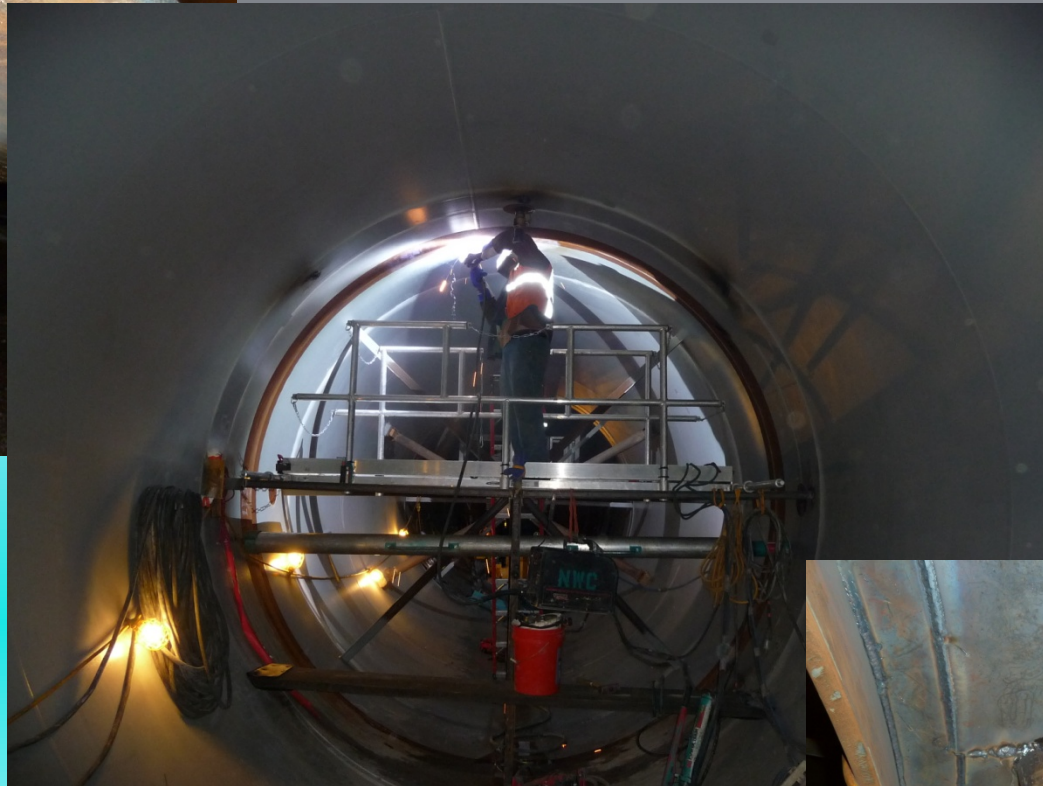
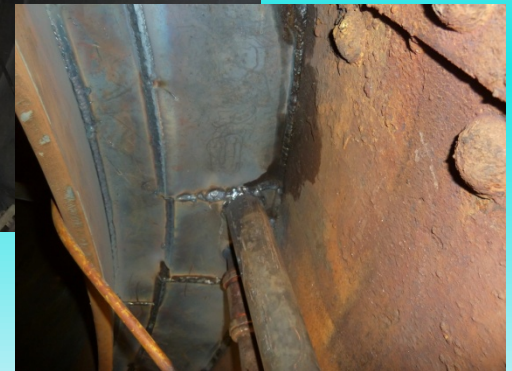
Supports, Weld and Grout Dams

UNIQUE SUPPORTS,
DAMS AND WELDING
WERE REQUIRED
